Type 02

Category: Facade elements

Ground- and 1st-floor column coverings

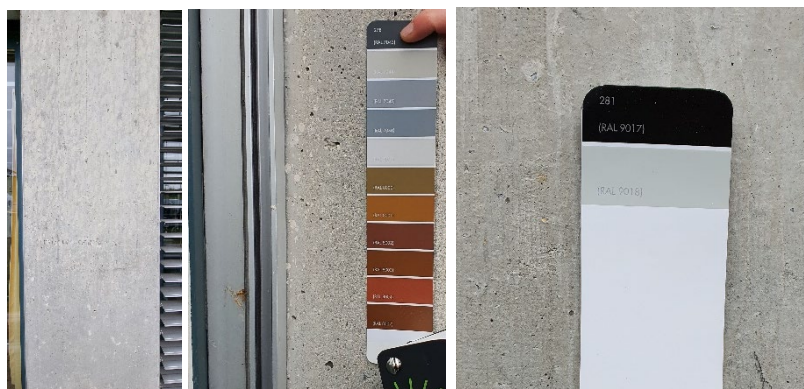
Color and finishing

Description				Condition and durability	
Exposition	Outdoor, exposed to rain and water flow			Condition assessment	45% good
Color	Grey with a yellowish tint, closest RAL 7044 or 9018				45% acceptable
Finishing	Horizontal wood plank patterns				10% deviant
Actual location	E, W and S facades			Carbonatation depth [mm]	Avg. 2-16 (max 19)
Initial function	Facade self-supporting element			Toxic substance	PCB in joints
Accessibility	Moderate – One/two elements to dismantle before			Mechanical characteristics	
Anchor points	Not available			Density	2500 kg/m ³
Overlays	Type	Fixation	Thickness	Concrete compressive strength	41 N/mm ²
Outside	None	-	-	Concrete young modulus	38'600 N/mm ²
Inside	Window frame	n.a.	-	Reinforcement tensile strength	300 N/mm ²
Connexion type	Connected to other facade elements and foundation			Reinforcement young modulus	205'000 N/mm ²
Deconstruction tool	With facade elements		With foundation

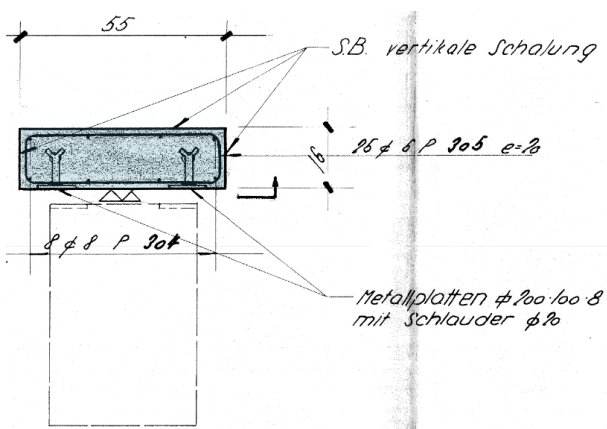
Subtype n°1, cross-section

Additional note	<ul style="list-style-type: none"> > Stirrups of Ø 8 spaced every 250 mm are present. > The carbonatation depth is lower than the 20-mm concrete cover of the rebars. > The depth of carbonatation is less important for the elements of the southern facade.
Attention point	<ul style="list-style-type: none"> > The waterproofing joints sealant placed between the facade elements probably contain polychlorinated biphenyls (PCB). These joints must be completely removed by a specialized company. The removal can be done with a cutter, while avoiding heating the joints or producing dust. > Contamination with PCBs of the concrete neighboring the joints should be checked by further sampling. Most probably, it will be necessary to remove 1cm of the edge that was in contact with the joint.
