Zürich – Stadtspital Triemli Personalhäuser

Resource assessment of structural elements

Version 1.4 – January 2022
DOI: 10.5281/zenodo.6020923

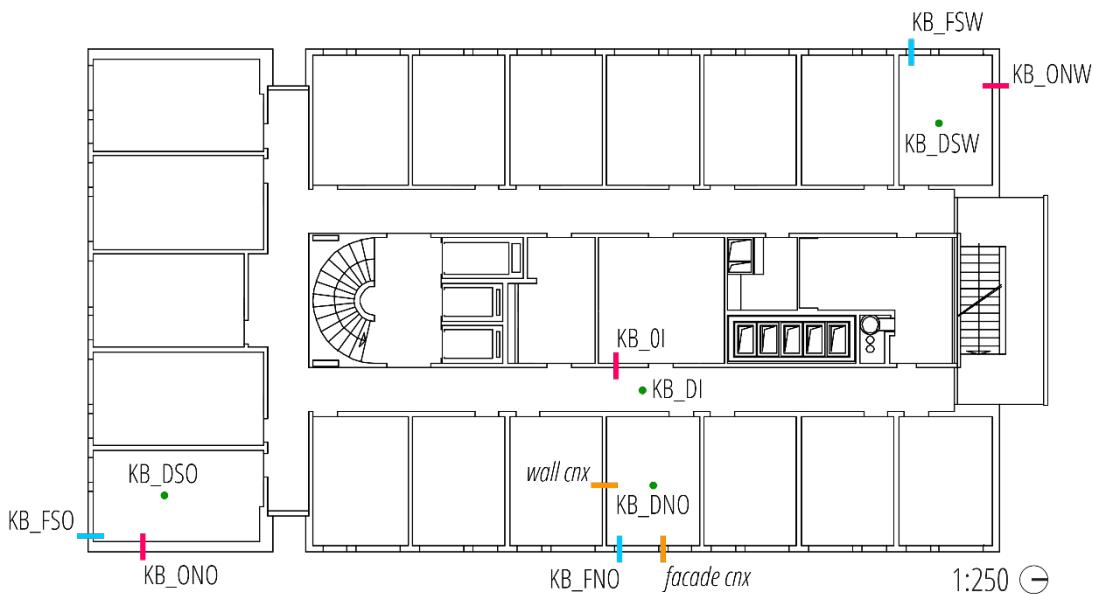
Figure 11. Localization of cores on floor plan

The carbonatation depth measured on the different cores is compared to the cover concrete thickness in Table 3. The detailed reports from the laboratory are given in Annex 4 – Carbonatation and cover concrete thickness measurements.

The depths of carbonatation are always lower than the cover thickness of the reinforcement. Thus, the concrete is not carbonated in the reinforcement areas and the risk of corrosion is kept low.

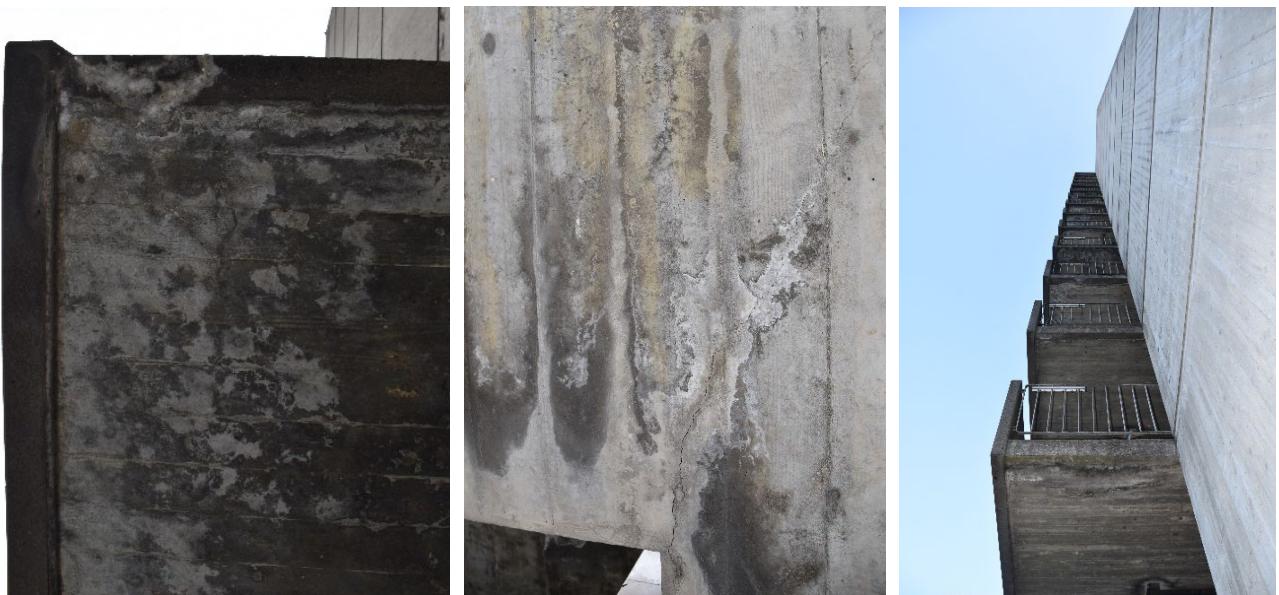
Figure 12. Balcony slabs

Discarded elements	Condition	Elements	Dimensions	Quantity	Area	Volume	Significance
Balcony slabs	Bad	-	6900 x 2930 x 200 mm	45 u	909,7 m ²	182,0 m ³	2,6%
Roof slabs	Bad	-	25840 x 7350 x 160 mm	569,8 m ²	-	91,2 m ³	1,3%
Outdoor stairs	Bad	n°19	2780 x 1350 x 2730 mm	42 u	157,6 m ²	3,7 m ³	0,1%
