Type 01

Category: Facade elements

## Balcony railings

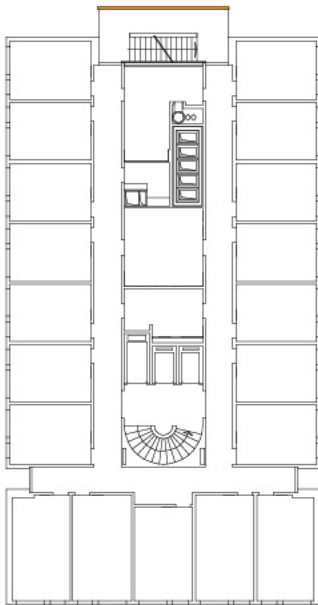
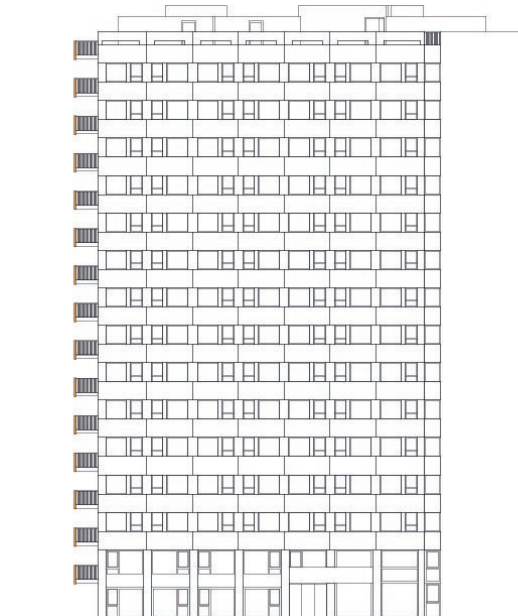
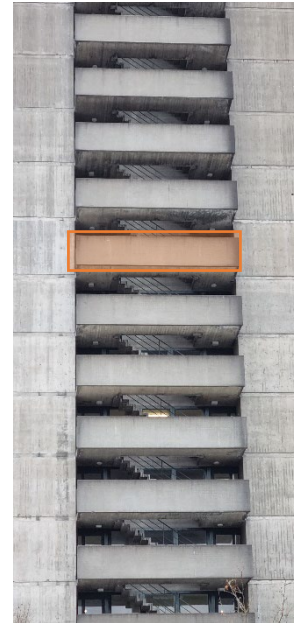
### Location

Exposition	Outdoor, exposed to rain and water flow		
Color	Shade of grey, closest RAL 7023 or 7003		
Finishing	Horizontal wood plank patterns		
Actual location	N facade		
Initial function	Facade self-supporting element		
Accessibility	Easy – No further demolition required before		
Anchor points	Available		
Overlays	Type	Fixation	Thickness
	None	-	-
Connexion type	Embedded connection to the balcony slab		
Deconstruction tool	Diamond saw

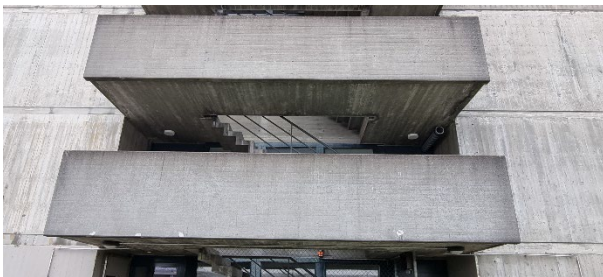
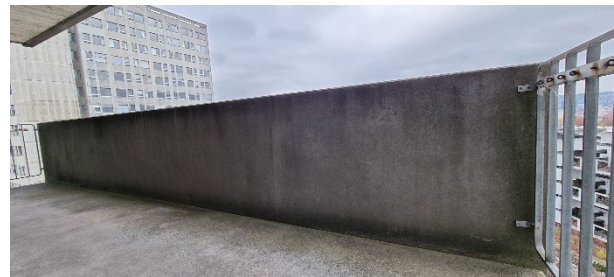
### Balcony railings

Condition assessment	7 % good
	86 % acceptable
	7 % deviant
Carbonatation depth [mm]	Avg. 16 (max 19)
Toxic substance	PCB in joints
<b>Mechanical characteristics</b>	
Density	2500 kg/m <sup>3</sup>
Concrete compressive strength	41 N/mm <sup>2</sup>
Concrete young modulus	38'600 N/mm <sup>2</sup>
Reinforcement tensile strength	450 N/mm <sup>2</sup>
Reinforcement young modulus	205'000 N/mm <sup>2</sup>

<b>Additional note</b>	<ul style="list-style-type: none"> <li>&gt; The elements are connected to the balcony slabs by stirrups Ø 8 spaced every 250 mm.</li> <li>&gt; The carbonatation depth is lower than the 20-mm concrete cover of the rebars.</li> <li>&gt; For horizontal storage of the balcony element, support spacers should be placed every 1.8 m.</li> </ul>
<b>Attention point</b>	<ul style="list-style-type: none"> <li>&gt; Vertical rebars are not anchored at the section end. The resistance is reduced in those areas.</li> <li>&gt; The waterproofing joints sealant placed between the facade elements probably contain polychlorinated biphenyls (PCB). These joints must be completely removed by a specialized company. The removal can be done with a cutter, while avoiding heating the joints or producing dust.</li> <li>&gt; Contamination with PCBs of the concrete neighboring the joints should be checked by further sampling. Most probably, it will be necessary to remove 1cm of the edge that was in contact with the joint.</li> </ul>
