Type 02

Category: Facade elements

Ground- and 1st-floor column coverings

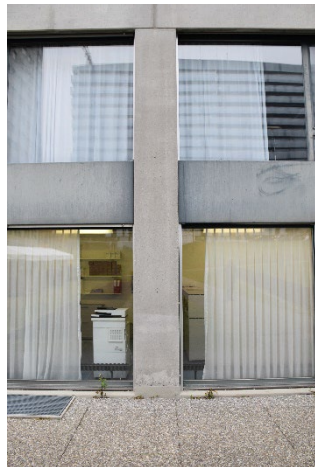
Ground- and 1st-floor column coverings

Description				Condition and durability	
Exposition	Outdoor, exposed to rain and water flow			Condition assessment	45% good
Color	Grey with a yellowish tint, closest RAL 7044 or 9018				45% acceptable
Finishing	Horizontal wood plank patterns				10% deviant
Actual location	E, W and S facades			Carbonatation depth [mm]	Avg. 2-16 (max 19)
Initial function	Facade self-supporting element			Toxic substance	PCB in joints
Accessibility	Moderate – One/two elements to dismantle before			Mechanical characteristics	
Anchor points	Not available			Density	2500 kg/m ³
Overlays	Type	Fixation	Thickness	Concrete compressive strength	41 N/mm ²
Outside	None	-	-	Concrete young modulus	38'600 N/mm ²
Inside	Window frame	n.a.	-	Reinforcement tensile strength	300 N/mm ²
Connexion type	Connected to other facade elements and foundation			Reinforcement young modulus	205'000 N/mm ²
Deconstruction tool	With facade elements		With foundation

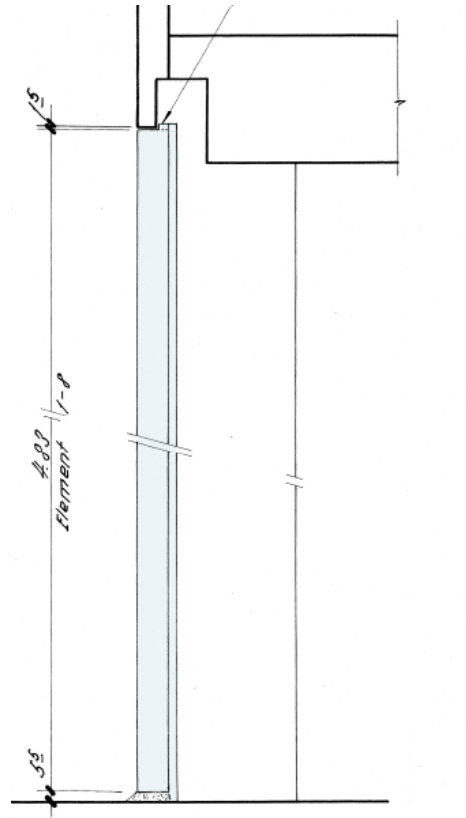
Subtype n°1, dimensions

Additional note	<ul style="list-style-type: none"> > Stirrups of Ø 8 spaced every 250 mm are present. > The carbonatation depth is lower than the 20-mm concrete cover of the rebars. > The depth of carbonatation is less important for the elements of the southern facade.
Attention point	<ul style="list-style-type: none"> > The waterproofing joints sealant placed between the facade elements probably contain polychlorinated biphenyls (PCB). These joints must be completely removed by a specialized company. The removal can be done with a cutter, while avoiding heating the joints or producing dust. > Contamination with PCBs of the concrete neighboring the joints should be checked by further sampling. Most probably, it will be necessary to remove 1cm of the edge that was in contact with the joint.
