Zürich – Stadtspital Triemli Personalhäuser

Resource assessment of structural elements

Version 1.4 – January 2022
DOI: 10.5281/zenodo.6020923

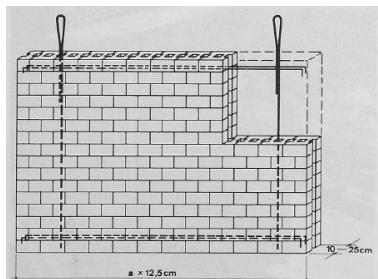
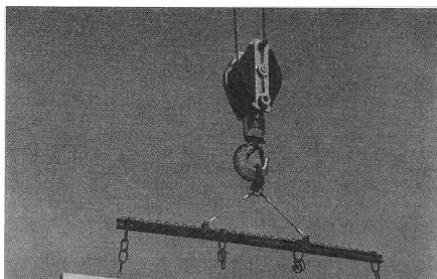
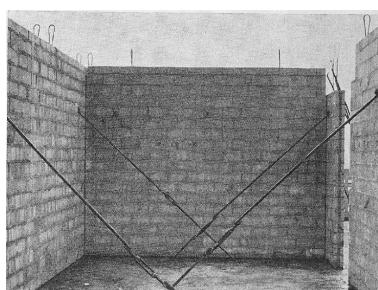
Preton wall

Condition assessment	n.a. (prob. good)
Carbonatation depth	n.a.
Toxic substance	None

- Additional note**
- > See historical paper on prefabricated masonry wall [20].
 - > The condition of these walls could not be assessed as they were covered by wallpaper. However, it is assumed to be good.

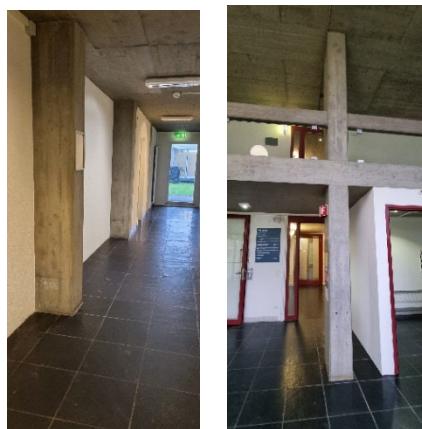
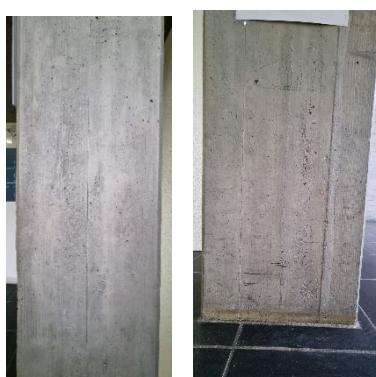
Cast-in-place columns

Description				Condition and durability												
				Condition assessment		100% good										
Exposition				Carbonatation depth [mm]												
Color				Avg. 8 (max 20)												
Finishing				Toxic substance												
Actual location				None												
Initial function				Mechanical characteristics												
Accessibility				Density												
Anchor points				2500 kg/m ³												
Overlays		Type	Fixation	Concrete compressive strength												
None		-	-	69 N/mm ²												
Connexion type		Connected with slabs														
Deconstruction tool		Diamond saw or hydro-blasting														
Element	Geometry			Inventory			Environmental impacts									
Subtype	Dimensions (W x L x T) [mm]	Reinforcement [mm]	Cross-section resistance [kNm]	Quantity [u]	Weight [kg/u]	Total volume [m ³]	Significance	Initial production [kgCO ₂ -eq/u]	Conventional demolition [kgCO ₂ -eq/u]							
East and west near-facade	450 x 300 x 2540	6 x Ø 14	43,8	72	857	24,7	0,4%	76	9

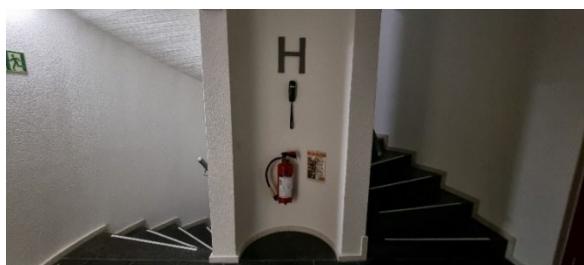
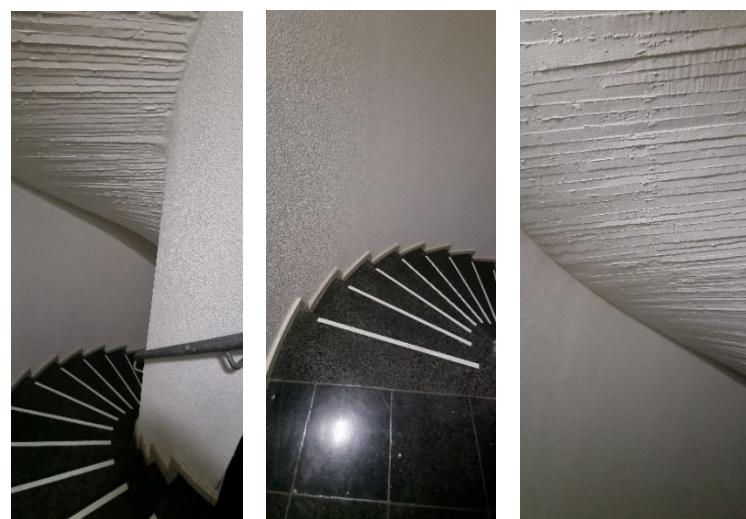
Indoor staircase

Condition assessment	100% good
Carbonatation depth [mm]	Avg. 8 (max 20)
Toxic substance	None
